## 8D Report: AP3 Bouncy Motor Switch

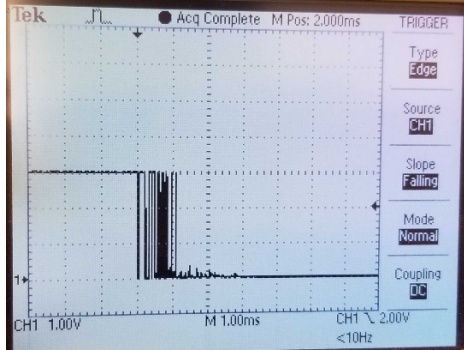
<ul style="list-style-type: none"> <li>• Why was the operating range larger than the previous builds?             <ul style="list-style-type: none"> <li>- It is common for different build lots to have slightly different tolerance ranges, but the overall specs provided by the Manufacturer will account for their variances.</li> </ul> </li> </ul>
<p>5</p>	<p><b>Identify Solutions</b>          What are the possible solutions? Identify the best. Address the root cause. What Permanent Corrective Actions will we take?</p>	<p>Konrad identified that we could classify motor switches into three categories using a test fixture that isolated the motor switch and operated on it in an ideal manner.</p> <p>Type 1 - State change of the switch stabilizes within 0.005 seconds. This is a switch operating within our tolerance range.</p>

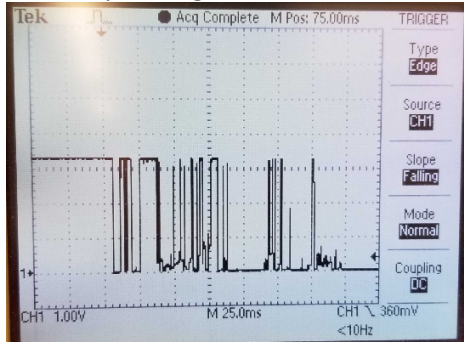
<p>Type 2 - State change of the switch stabilizes &gt; 0.005 seconds. This is a switch operating within the manufacturer's full tolerance range.</p>

<p>Konrad created an embedded software update running inside every lock that compensates for the characteristics of Type 2 motor switches. With this firmware update, locks with Type 2 switches behave as expected within their service life. This firmware update can be easily applied in the field by our users with no additional tools or software.</p>

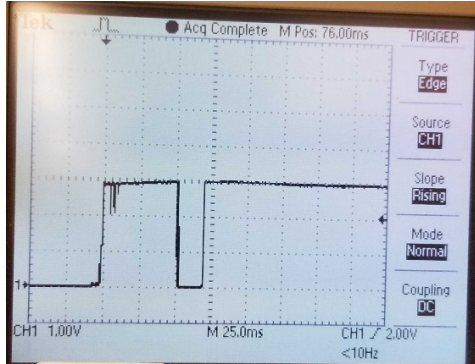
<p>Type 3 - Stabilizes within the acceptable time span, but changes states when in a static state. This is not a properly working switch.</p>

<b>Identify Solutions cont.</b>	There is no fix for Type 3 motor switches, so we created a test (BMS Test) that can be run on a fully assembled AP3 which will indicate the presence of Type 3 motor switches. All locks identified with Type 3 motor switches are considered failures, should be removed from active service, and automatically qualify for RMA and credit.
6	<b>Validation</b> Verify that the solution is working as expected. Check for undesirable side-effects.	Locks with the new software saw a substantial decline in open and close failures. Any remaining inventory was re-tested and screened for BMS failure.  To validate the BMS Test procedure, failed switches are removed from the lock and tested in a jig to confirm the test identified the fault correctly.
7	<b>Prevention</b> What improvements in systems and processes will prevent this and similar problems from recurring?	We are introducing the BMS Test at the factory for all future production.  The BMS Test includes 9 additional pass/fail criteria for our automated open-and-close test procedures.
